# *4 Seasons Home Inspections LLC*

## Property Inspection Report

123 North 1st Street, Seattle, WA 98105  
Inspection prepared for: Report Sample  
Date of Inspection: 2/24/2013 Time: 9am  
Age of Home: 86 yrs Size: 2540 sqft  
Weather: Cloudy; Temperature is 45 degrees  
Report # 13061

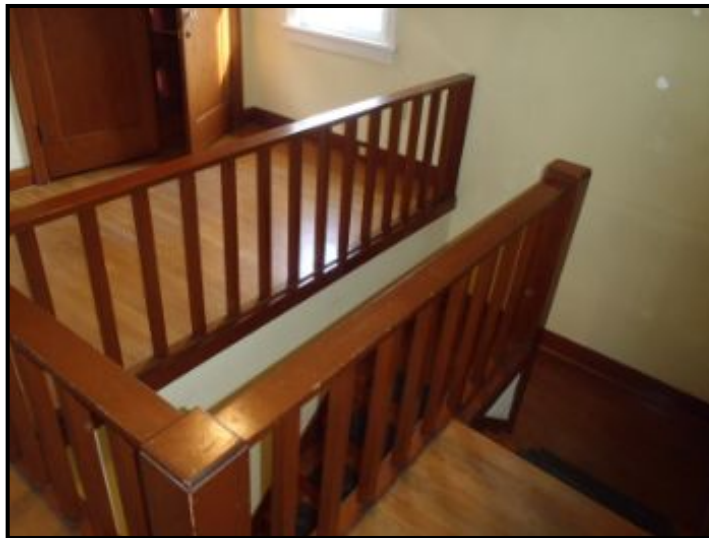
- The opening between spindles is over 4 inches wide .
- The height of the guardrail should not be less than 36 inches.

The opening between spindles is over 4 inches wide .

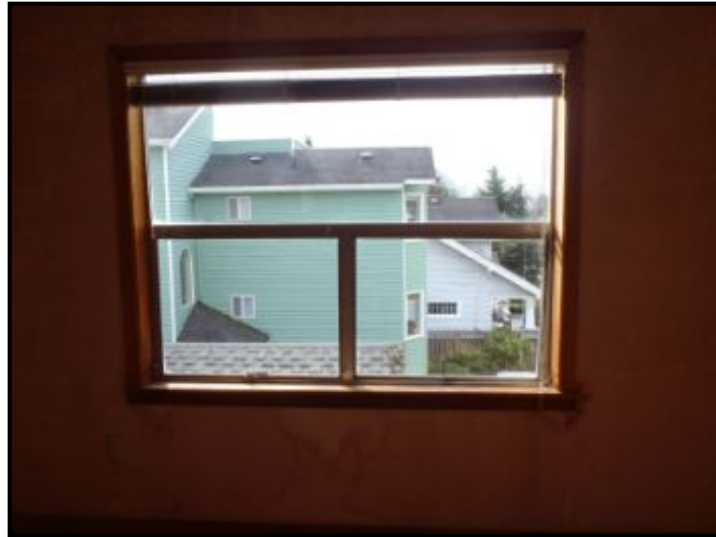
Rear upper bedroom window does not shut properly.

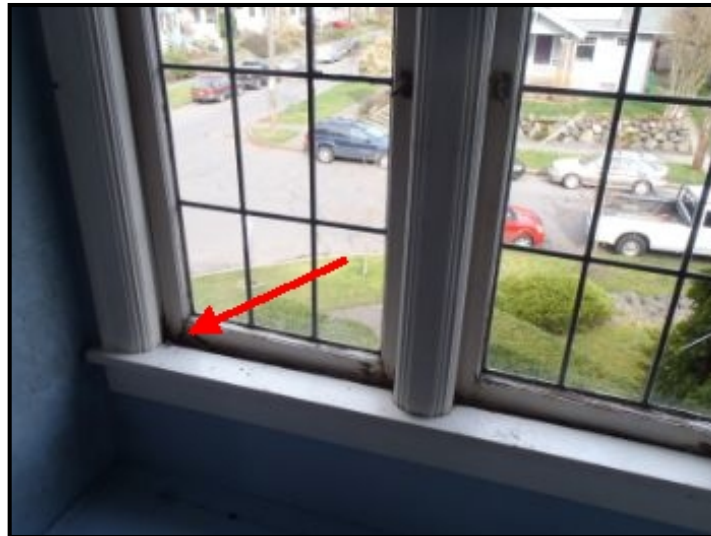
- One or more windows did not lock/latch properly, recommend repairs for enhanced security/safety to occupants.
- Broken/cracked glass pane noted, repairs needed.
- Single pane windows observed, recommend budgeting for replacement for added efficiency of home.
- Deterioration of wooden frames noted. While basic maintenance may prolong the life of these window frames, replacement may be necessary at some point.

Deterioration of wooden frames noted. While basic maintenance may prolong the life of these window frames, replacement may be necessary at some point.

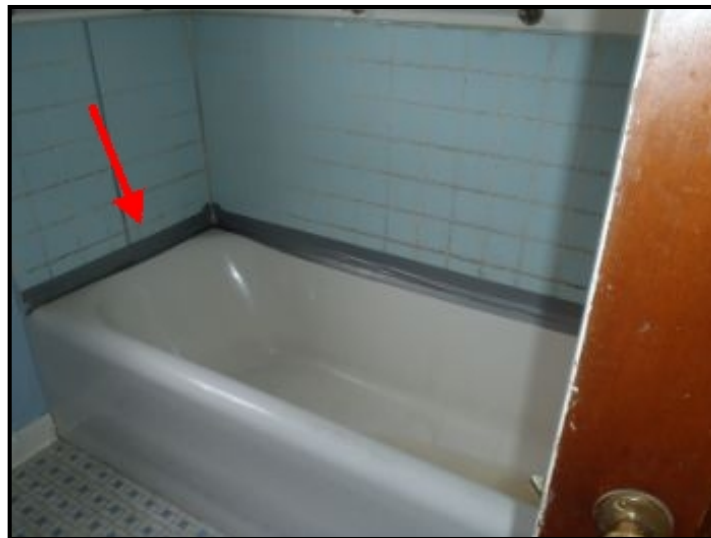
Observations:  
 • Plastic tub/shower surround noted.  
 • There is duct tape covering the edge of the shower around the entire perimeter. Recommend repair.

The is duct tape covering the edge of the shower around the entire perimeter. Recommend repair.

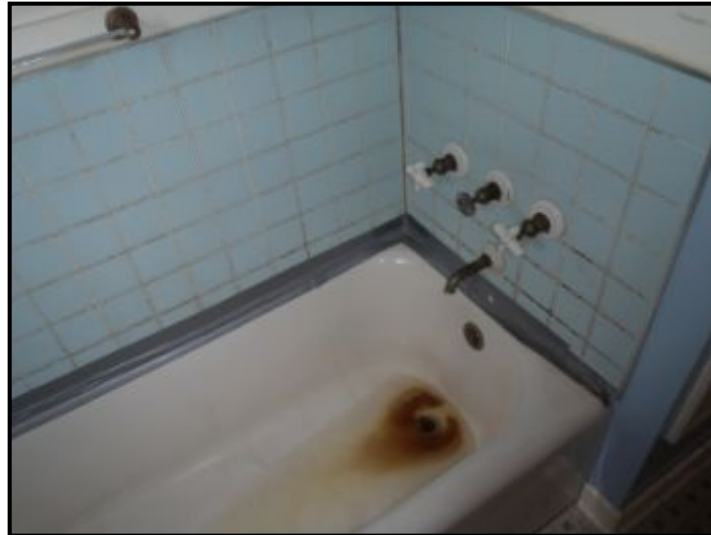
Observations:  
 • Stains observed.  
 • Stopper is inoperable.  
 • There is no water functioning in the bathtub.  
 • The bathtub drain is clogged.

There is no water functioning in the bathtub.

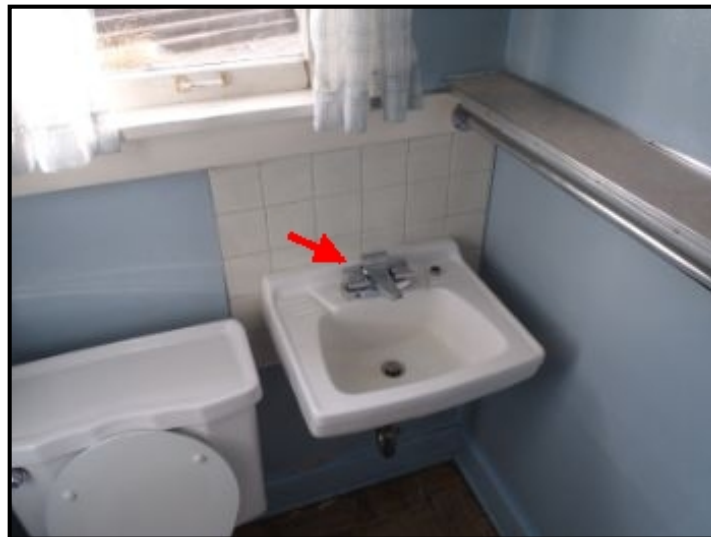
Observations:  
• **Poor pressure flow from the sink faucet.**

Poor pressure flow from the sink faucet.

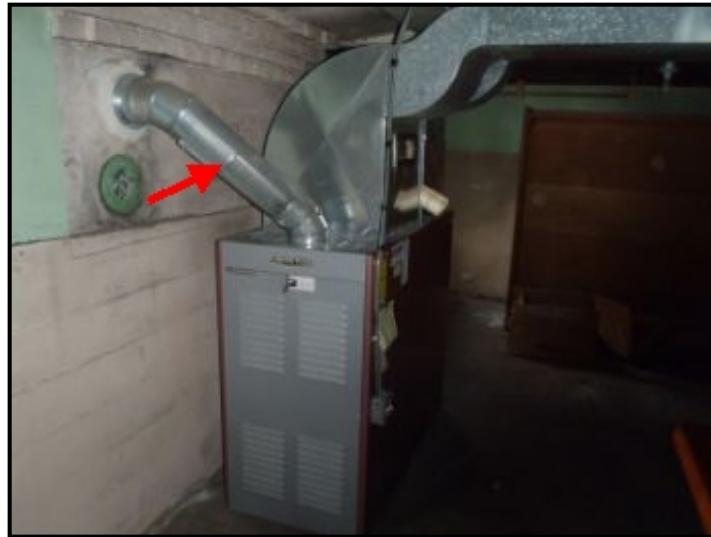
Observations:  
 • A barometric damper is missing in the exhaust vent system. Recommend repair.

A barometric damper is missing in the exhaust vent system. Recommend repair.

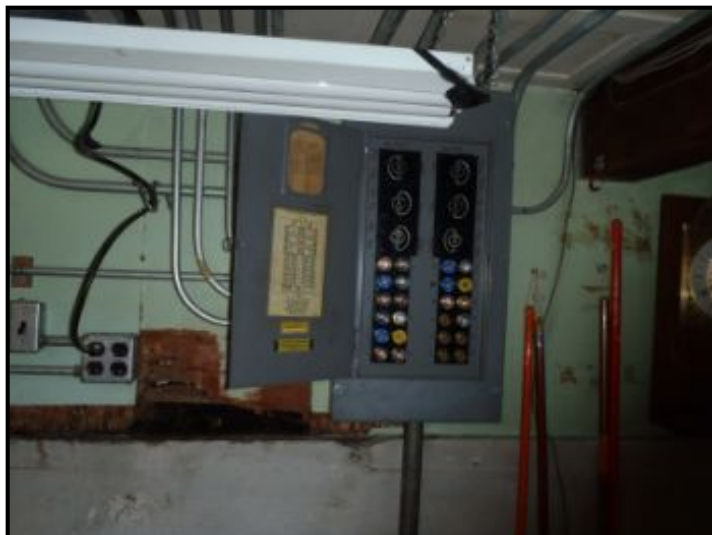
- Recommend updating the service panel to circuit breakers.
- Missing fuses noted.

Recommend updating the service panel to circuit breakers.

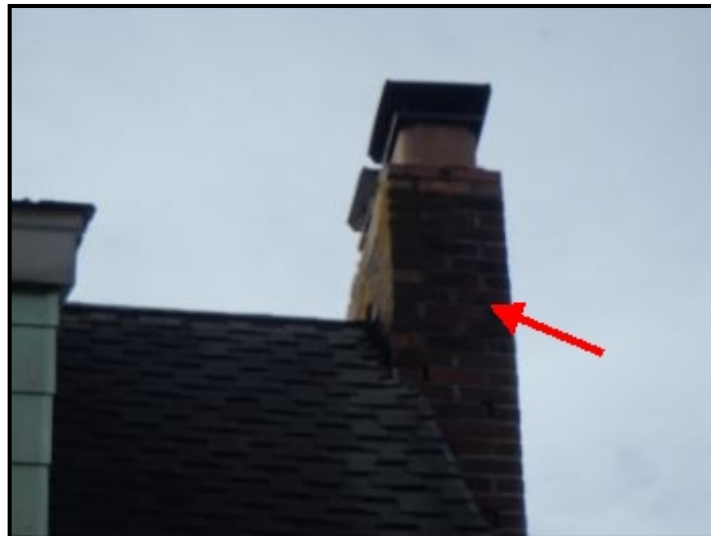
- Minor mortar deterioration at chimney; moss present. Recommend cleaning and maintenance as needed.

Minor mortar deterioration at chimney; moss present. Recommend cleaning and maintenance as needed.

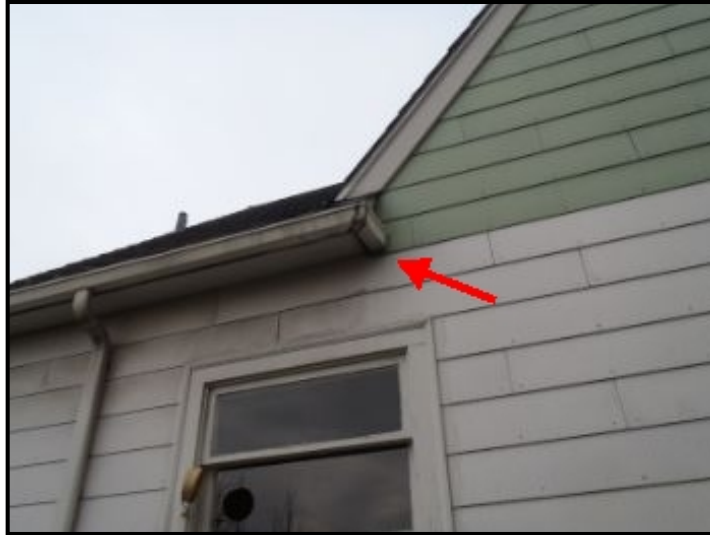
- Gutter leak noted on left side of the house.

Gutter leak noted on left side of the house.

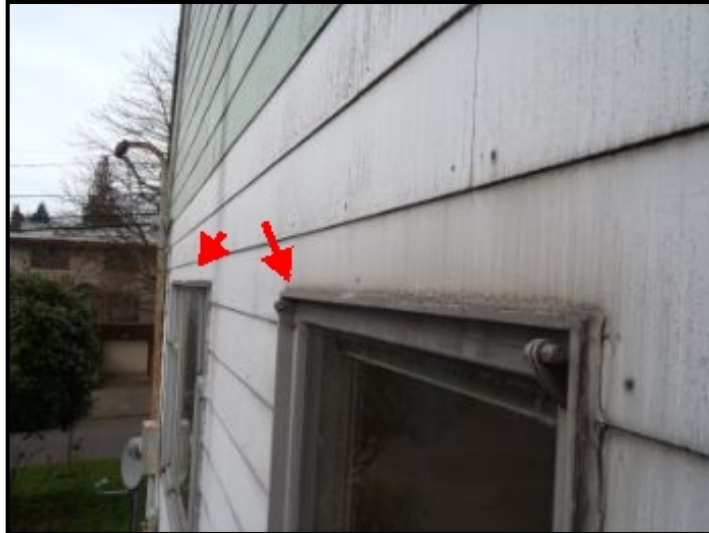
- All exterior window headers are missing properly installed flashings and show some signs of leakage into the house from the window frames. All stains tested dry at the time of inspection. Most of the caulking installed around the frames have deteriorated and are in need of recaulking.

All exterior window headers are missing properly installed flashings and show some signs of leakage into the house from the window frames. All stains tested dry at the time of inspection. Most of the caulking installed around the frames have deteriorated and are in need of recaulking.

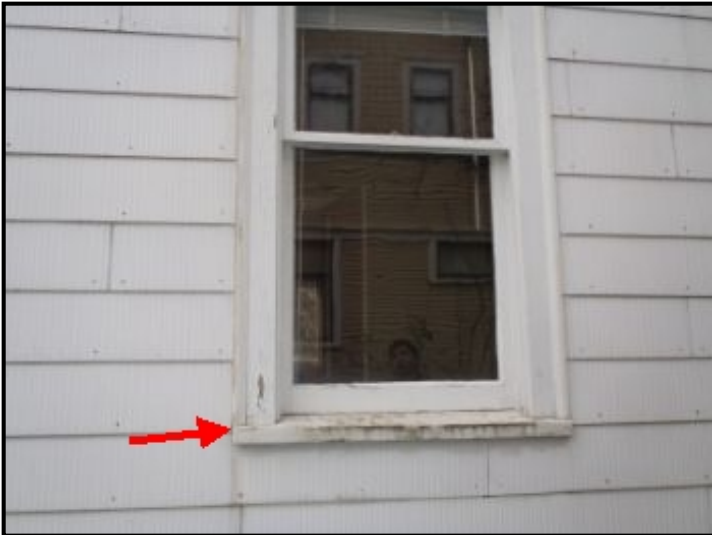
Split Caulking and peeling paint noted around all windows.

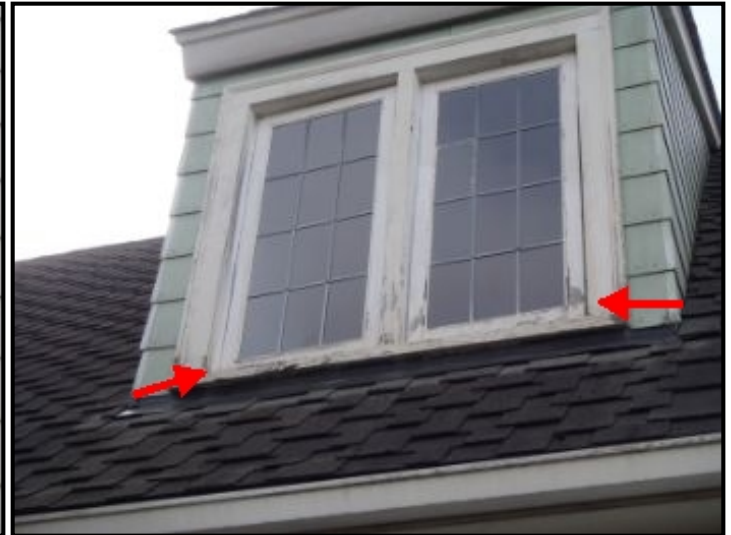
Deteriorated frame(s) at a number of upper windows.

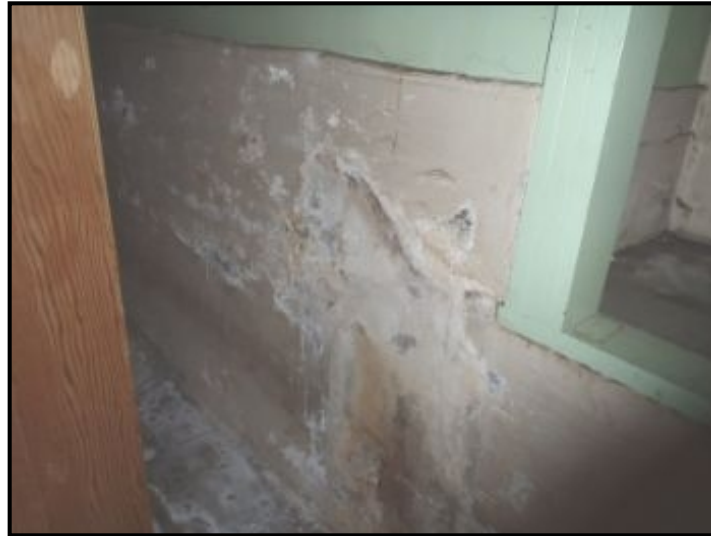
- Efflorescence observed; this is a mineral deposit left behind from previous exterior water infiltration.

Efflorescence observed; this is a mineral deposit left behind from previous exterior water infiltration.

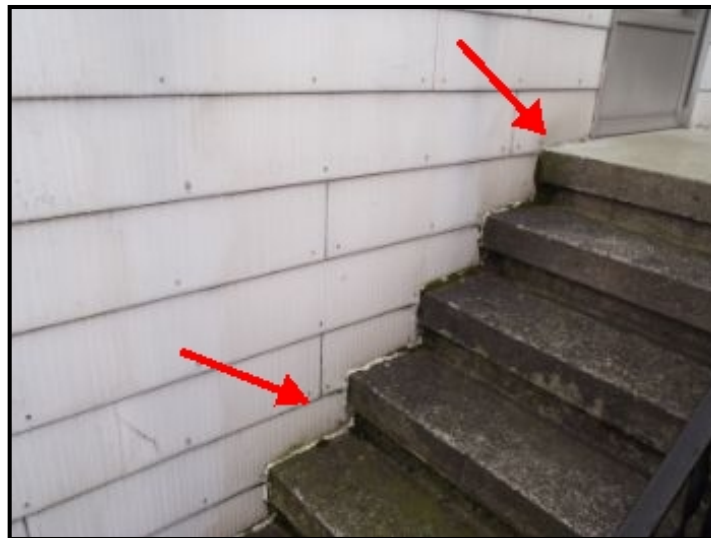
- Rear concrete deck has been leaking into the house where the deck attached to the house. It is improperly flashed.

Rear concrete stairs and deck has been leaking into the house at the caulk joint.

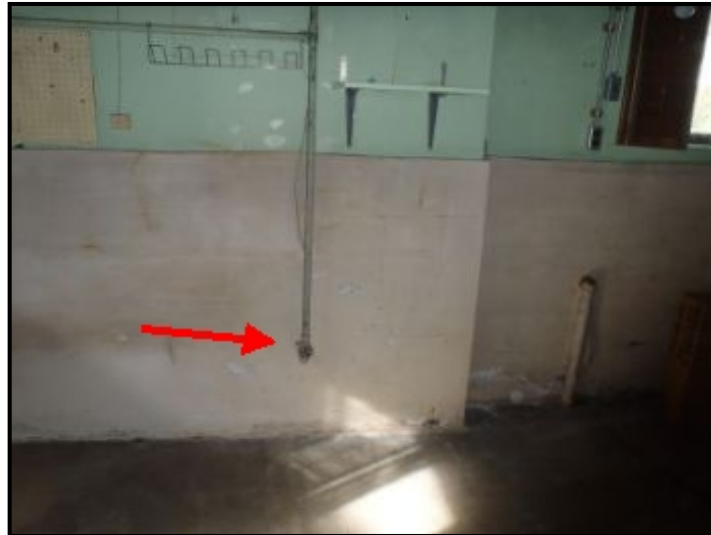
- Home is equipped with a Galvanized main water line. Typical lifespan of galvanized plumbing is 30 years. Recommend budgeting for replacement in the future due to the restriction/ loss of pressure/rust in water/rupture or leaks due to corrosion of pipes from the inside surface.

Home is equipped with a Galvanized main water line. Typical lifespan of galvanized plumbing is 30 years. Recommend budgeting for replacement in the future due to the restriction/ loss of pressure/rust in water/rupture or leaks due to corrosion of pipes from the inside surface.

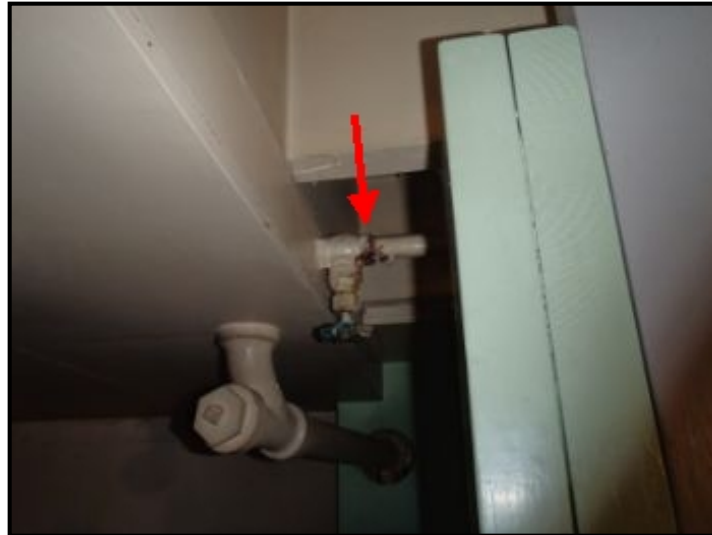
- Home is equipped with portions of Galvanized water lines. Typical lifespan of galvanized plumbing is 30 years. Recommend budgeting for replacement in the future due to the restriction/ loss of pressure/rust in water/rupture or leaks due to corrosion of pipes from the inside surface.
- There is a leak in the water line in the basement under the front main entry door area.

There is a leak in the water line in the basement under the front main entry door area.
